# **HID® FARGO® HDP®6600**

## **Printer Firmware**

### Release Notes

Firmware Version: 10.0.46.592  
PLT-04251, B.1  
June 2025

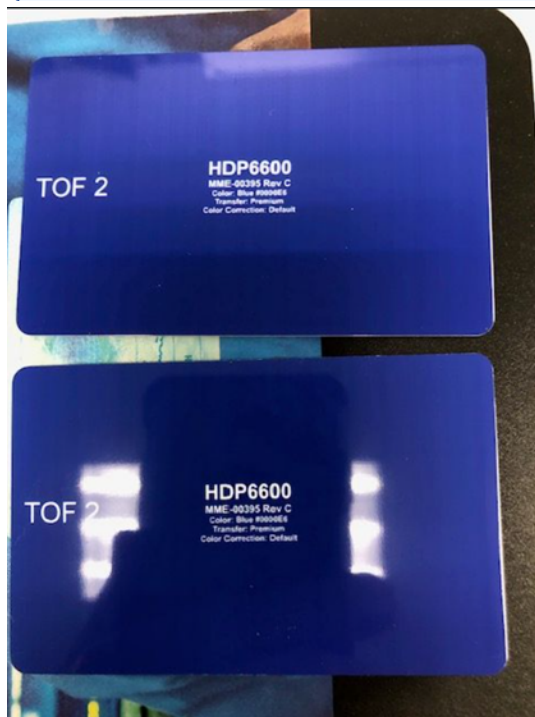
- Added **Transfer TOF Offset – Reverse Side** setting. This allows you to change the **Transfer TOF** on the back side of the card without affecting the front side TOF. (FSA2-1704, FSA-1147)

**Note:** If this setting, **Transfer TOF Offset - Reverse Side** is needed, you can adjust this setting by changing the current default value by -1. For example, change the setting from 0 to -1, then to -2, and so on. Increment by one step at a time until the white gap is gone. Typically a setting in the range of -1 to -10 fixes most printers.
