# **HID® FARGO® HDP®ii Printer Firmware**

## **Release Notes**

Firmware Version: 5.8.4  
PLT-04241, A.3  
October 2020

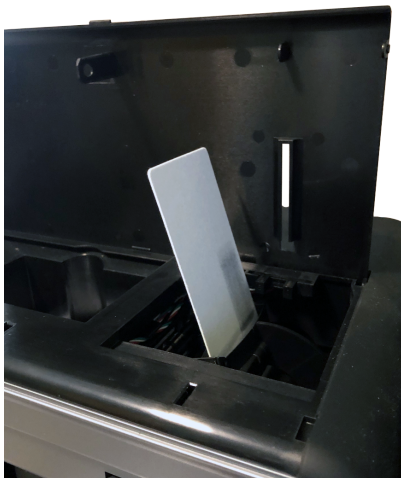
**Note:** The cleaning card must be fully inserted into magnetic encoder while advancing with the buttons, as shown.

The card should be inserted with the motor advancing for at least one minute so that the roller is fully cleaned by the card.

- To make it easier to use the long alcohol cleaning card with the mag encoder the printer has been modified to automatically rotate the flipper table to the correct angle for inserting the cleaning card. Previously, you had to manually rotate the flipper table and guess at the appropriate angle to feed the cleaning card down into the encoder module. With the 5.8.4 firmware, if the top cover to the reject bin is open and the front cover to the ribbon and film cartridges is closed, the flipper table will rotate to the correct angle. The card can then be inserted carefully into the flipper table and the display buttons can be used to advance or retract the cleaning card.
